**THREE CASE HISTORIES OF CRACKING PROBLEMS
ASSOCIATED WITH
STEEL BRIDGE FLOOR BEAMS**

By
W. H. Walker
M. D. Holbrook
and
P. A. Cassity

A Report on a Research Project
Sponsored by the
STATE OF ILLINOIS
DEPARTMENT OF TRANSPORTATION and the
U. S. DEPARTMENT OF TRANSPORTATION
Federal Highway Administration

DEPARTMENT OF CIVIL ENGINEERING
UNIVERSITY OF ILLINOIS AT
URBANA-CHAMPAIGN
URBANA, ILLINOIS
JUNE 1992

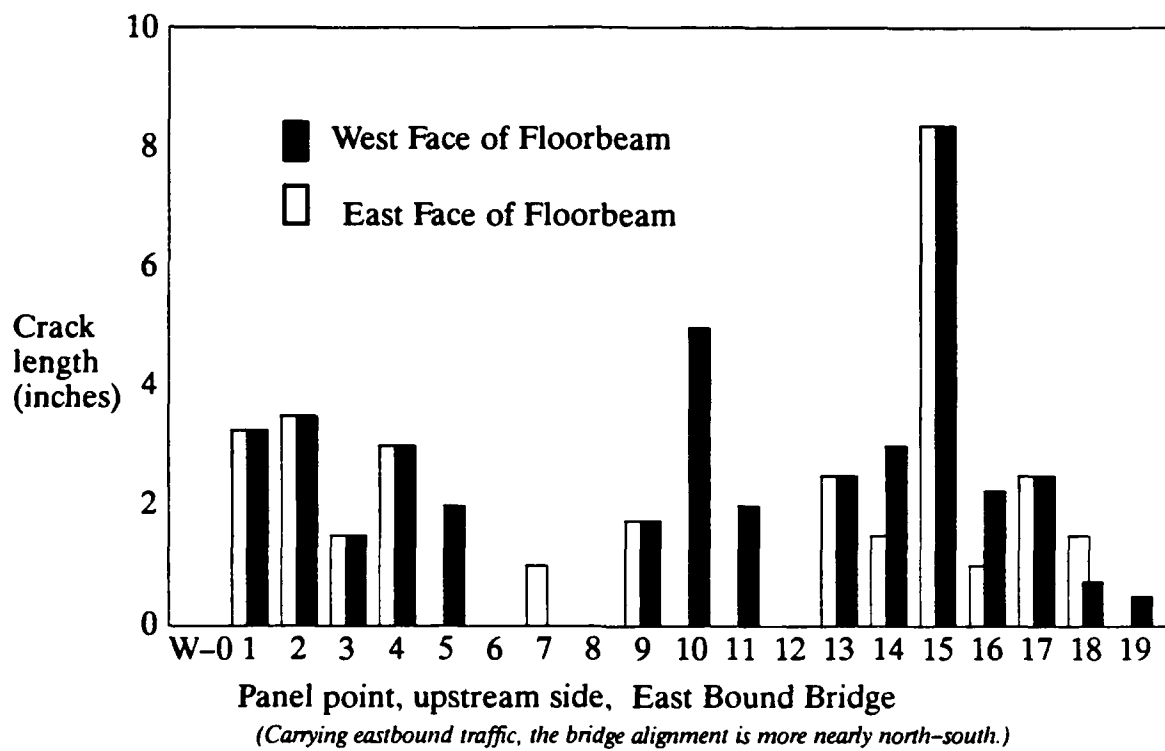
Fig. 3.4a Crack Measurements at Floorbeam Ends, Various Panel Points

The occurrence of the cracks in the floor beam ends at the top flange-to-web region at various panel points along the span is illustrated in Fig. 3.4a and 3.4b for half of the span carrying eastbound I-474 traffic. Fig. 3.4a refers to the upstream end of the floor beam and 3.4b to the downstream end. Note that the alignment of the bridge is more nearly north-south as it crosses the Illinois River at this location. These data come from the detailed tabulation [11] of inspection results for 1985 and 1986.

The most common crack lengths are on the order of 2 to 3 in., but with instances of locations where cracks of 6 to 8 in. are present.

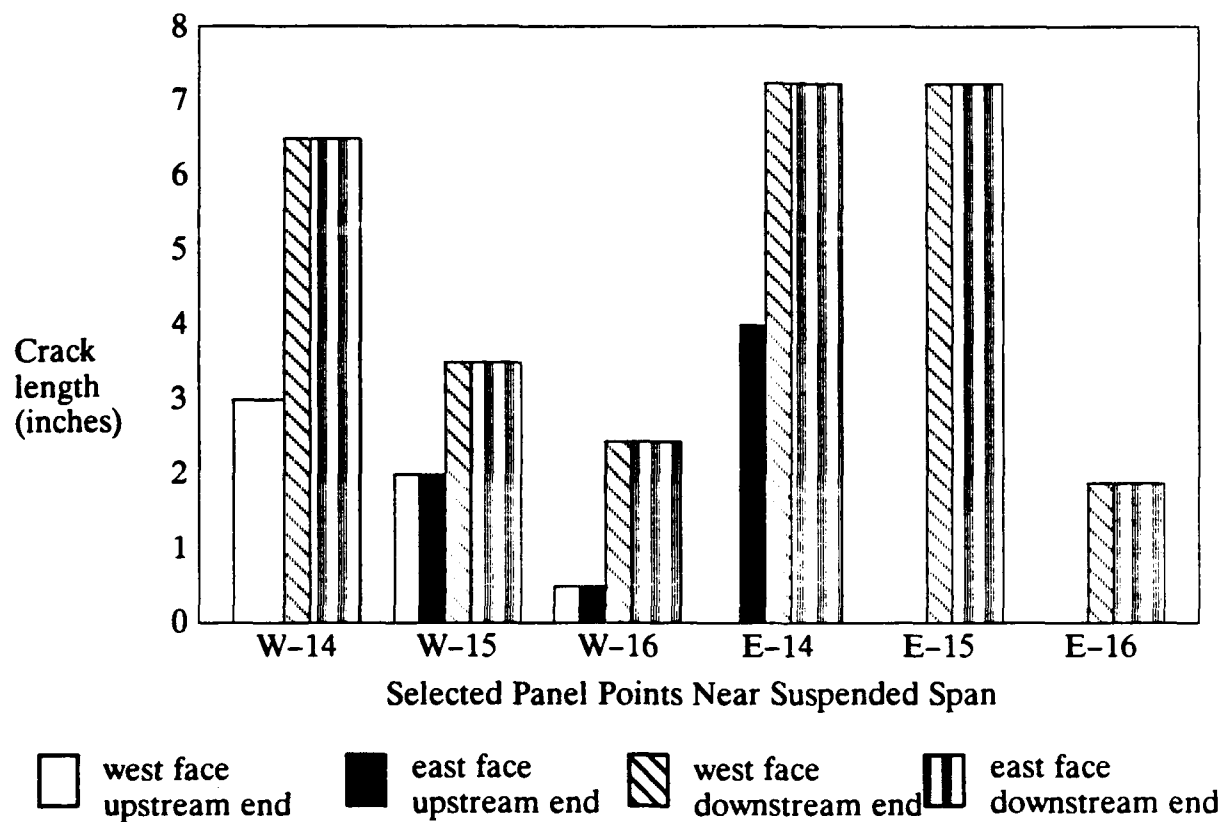
Fig. 3.5a Crack Measurements at Floorbeam Ends Near Suspended Span Hangers
West Bound Bridge

The above has emphasized sites where cracking occurs. In reviewing all data, the two truss spans have a total of 156 floorbeam end locations; if two faces of the web surface are considered, 312 possible surface crack locations exist to inspect. Of the 312 locations, 71 on the east bound and 57 on the west bound bridges, respectively, were found free of visible cracks or 46 % and 37 %, respectively, free of cracking. In Fig. 3.5a and 3.5b additional measurements are shown for both ends of the floorbeams located at panel points near the suspended span ends in both truss, i.e. carrying west and east bound traffic, respectively.

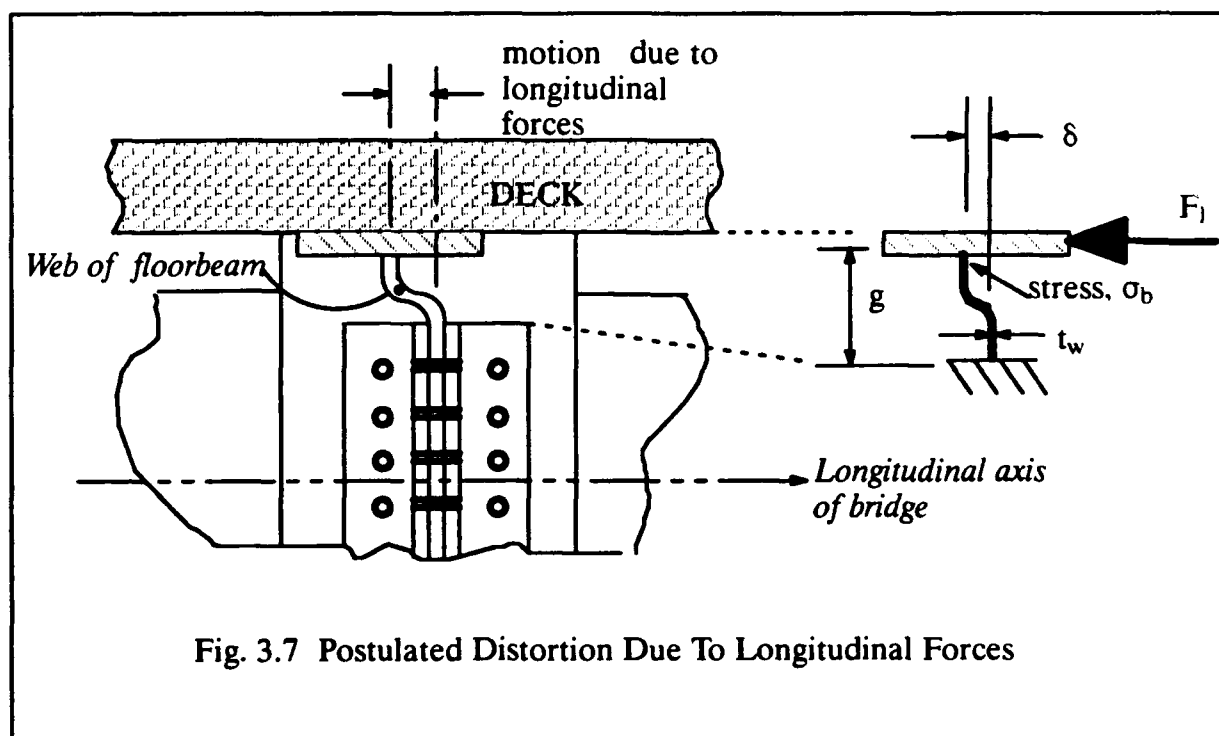
Fig. 3.7 Postulated Distortion Due To Longitudinal Forces

transmitted in flexure across the segment of web between the clip angles and the top flange -- a distance g on the sketch. For simplicity this web segment is treated as a fixed-fixed beam segment. To illustrate the sensitivity of the detail, a segment of web 12 in. long is considered. If $g = 4$ in. and $t_w = 3/8$ in. then the section modulus is $I = \frac{1}{12} b d^3 = 0.05273 \text{ in.}^4$, and $S = \frac{1}{6} b d^2 = 0.28125 \text{ in.}^3$. If the longitudinal force is taken to be $F_l = 1$ kip, then the calculated stress, σ_b , is 7.1 ksi and the deflection, δ , is only 0.0035 in. In contrast to the analysis on the previous page, if one modifies the calculation of N_p for the a stress range of 7.1 ksi, i.e. $C_1 = \frac{1}{A (1.985)^3 (7.1 \text{ ksi})^3}$, then $N_p = 4.2 \times 10^6$ cycles; if the stress range is as much as 14.2 ksi then only 580,000 cycles are required to propagate a 3 in. long crack. Thus if only a modest fraction of the vehicle longitudinal loads are transmitted in this manner a substantial stress range will be induced at the web-to-flange junction. The relatively small movement associated with a significant stress suggests that this phenomena may not be immediately evident during inspection without measurements in the field.

Thus the remedial repair detail for this mechanism of damage must provide a direct load path from the deck and floor beams to the truss at each panel point. A possible repair solution is shown in Fig. 3.8 and is modelled after that described by Fisher in the case cited

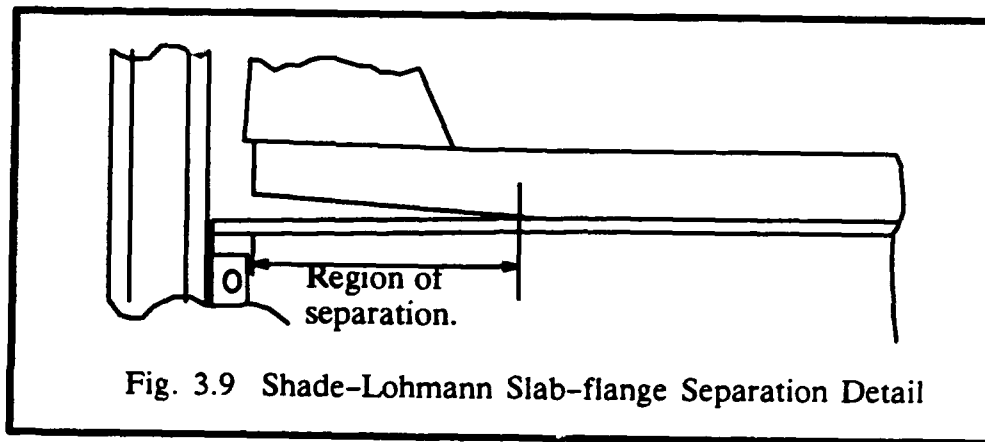
Fig. 3.9 Shade-Lohmann Slab-flange Separation Detail

Also, a detail where the slab is separated from the flange at the edge of the girder for some distance, see Fig. 3.9, was included on the drawings of the Shade-Lohmann Bridge, but it was not built as shown, presumably to permit the use of simpler form-work for the full width of the deck. The region of separation would have the possible effect of mitigating the stress concentration at the end of the floor beam to web detail and weld. It might also serve to direct more longitudinal force into the floor stringer system and to reduce the relative stiffness of the structural element at the top flange level carrying force into the clip angles. It is

not clear that the separation detail would prevent the development of the cracking seen. It is not proposed as a remedial detail.

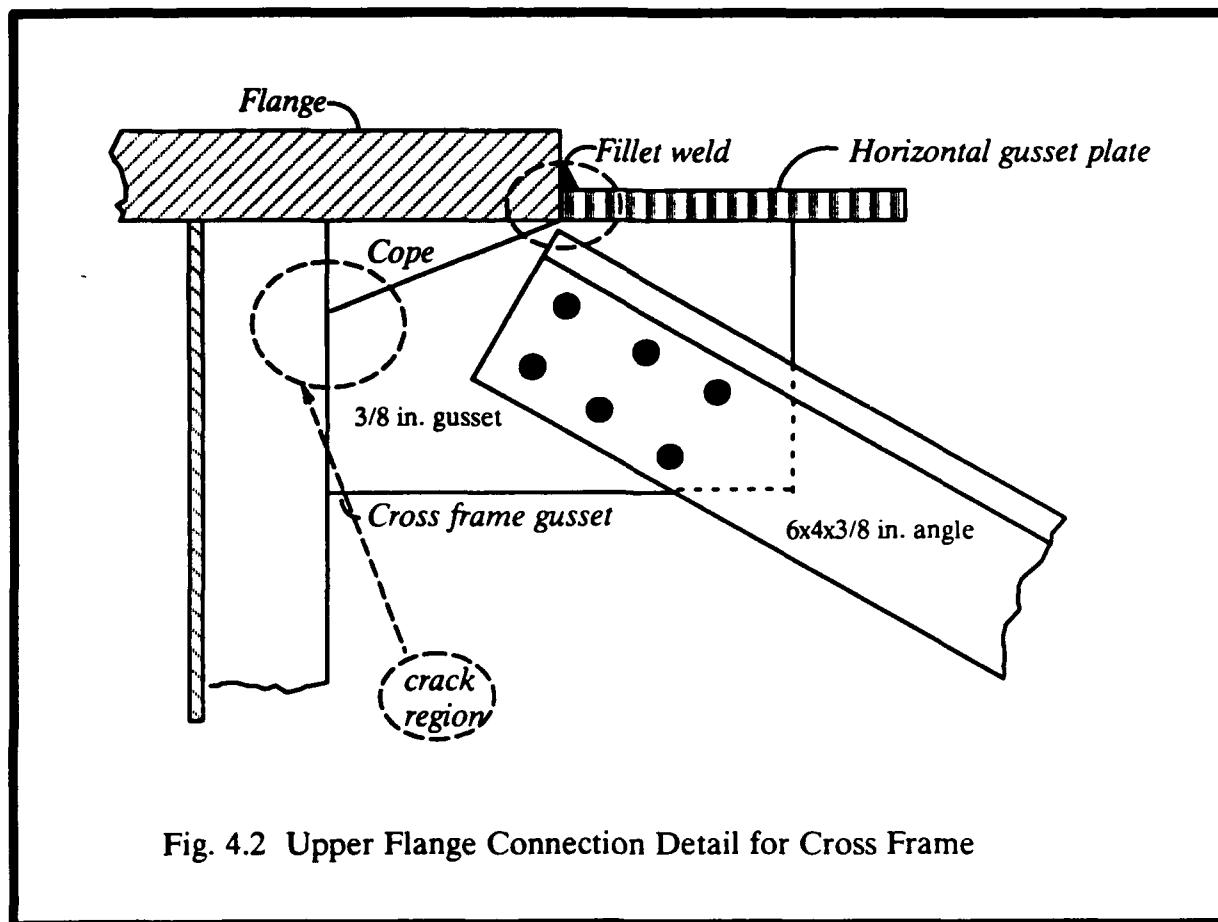
Fig. 4.2 Upper Flange Connection Detail for Cross Frame

As reported by the Illinois Department of Transportation, routine inspections have discovered cracks near the copes of some of the plates connecting the cross-framing to the main girders. Investigations have indicated possible poor weld details in these areas. A sketch of the detail found to be cracked is shown in Fig. 4.2. The combination of the severe

cope and the attachment to a gusset on the top flange of the girder represents a very un-favorable geometry.

The damage in this case history is clearly the result of fatigue at an unfavorable connection detail. The stress concentration at the cope and fillet weld is simply unacceptable as indicated by the cracking observed. The retrofit, given the limited effectiveness of the cross frames in the main structural action of the bridge, was designed to reduce the axial forces in the cross frame diagonals. The option of removing the cross frames is not acceptable since their presence does contribute to the stability of the structural system.

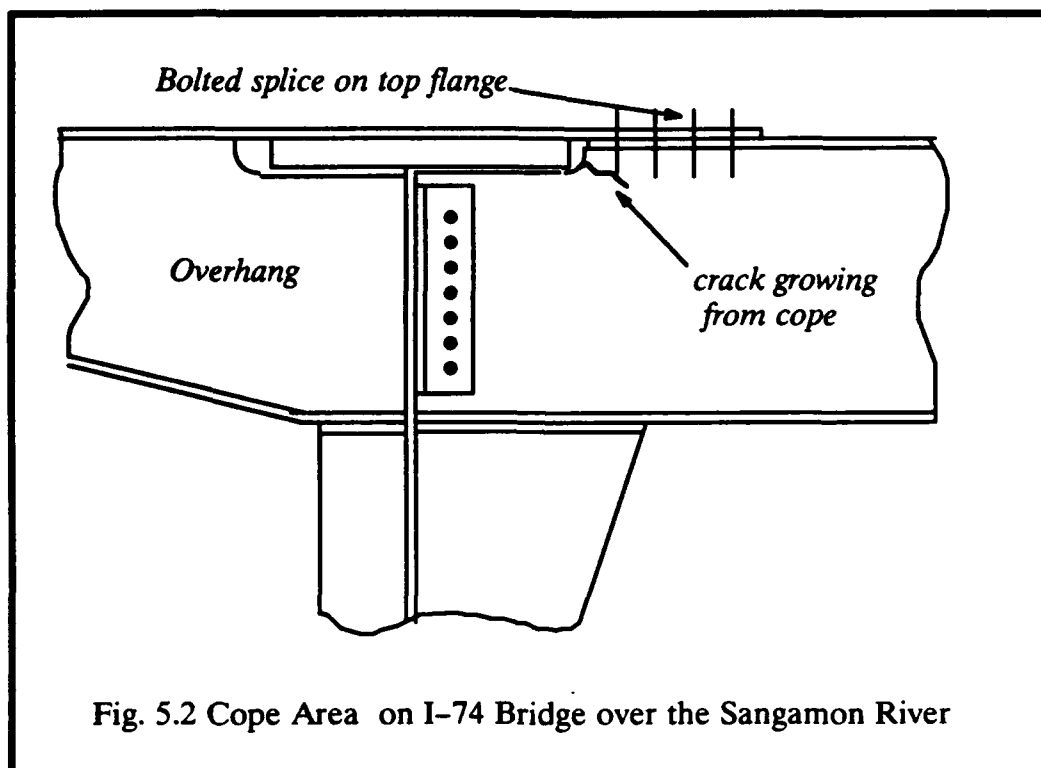
Fig. 5.2 Cope Area on I-74 Bridge over the Sangamon River

According to a report by the Illinois Department of Transportation [5], an inspection in December of 1984 revealed cracks at the copes of some of the floor beams, especially at floor beams located 22 to 33 feet from the west side abutment of the east-bound bridge.

Holes were drilled to arrest the cracks as a preliminary retrofit. This retrofit possibility was explored using a finite element analysis with the resulting conclusion that stress would not be suitably reduced. The use of reinforcing plates at the cope was recommended [7].
